Inspection Report Minerals Regulatory Program

Report Date November 29, 2005; Modified January 13, 2006

Mine Name: DKG Quarry
Operator Name: Diamond K Gypsum

Permit number: M/015/041
Inspection Date: November 22, 2005
Time: 11:00 AM to 12:20 PM

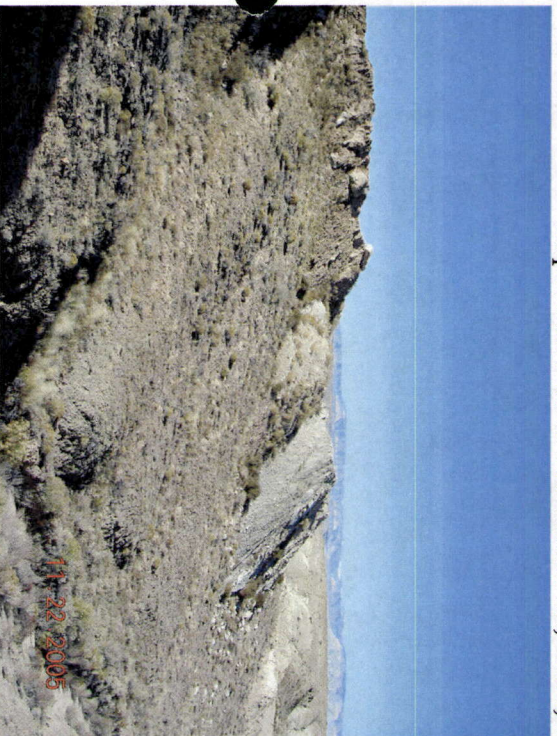
Photos 1 and 2 show a pile of waste material (mostly gypsum, it appears) that the operator will grade. This will mean disturbance of a slightly larger area.

Photo 1. The operator will try to knock down the pile of waste material in the center-right of this photo and cover it with soil.

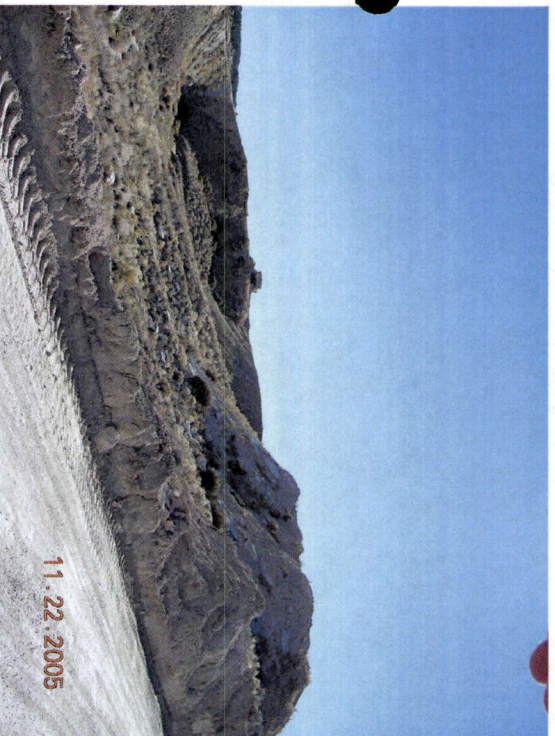
Photo 2. Another view of the waste material shown in Photo 1.

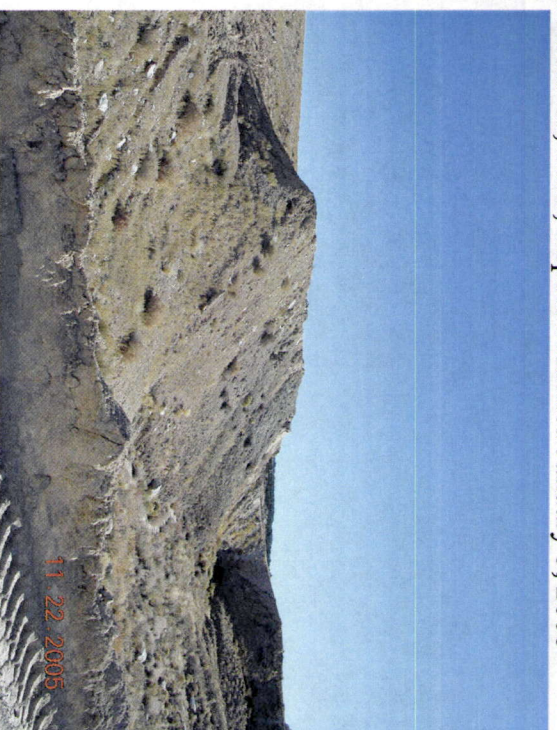
There is a natural drainage channel that begins about 100 yards above the area being reclaimed. This channel is blocked by the quarry, then there is a stretch that was not disturbed, then it is blocked again by the new road (Photo 3). This will create small impoundments when there is runoff, but this should not be a problem since the drainage area is small. It may enhance wildlife habitat since water is scarce in this area.

Photo 3. This mound is a rock outcrop that looks natural from this angle but not from the other side. This outcrop will be left.

The drainage near the center of this photo is blocked by the road in the foreground and also by the regraded mine. This drainage looks larger than it is; it only extends about 100 yards above the reclaimed area.

I asked the operator to slope the newly-regraded area so any runoff from this area would not flow into the drainage. Otherwise, it would increase the amount of water being ponded next to the road, and it might also create some erosion problems on the outslope of the quarry.

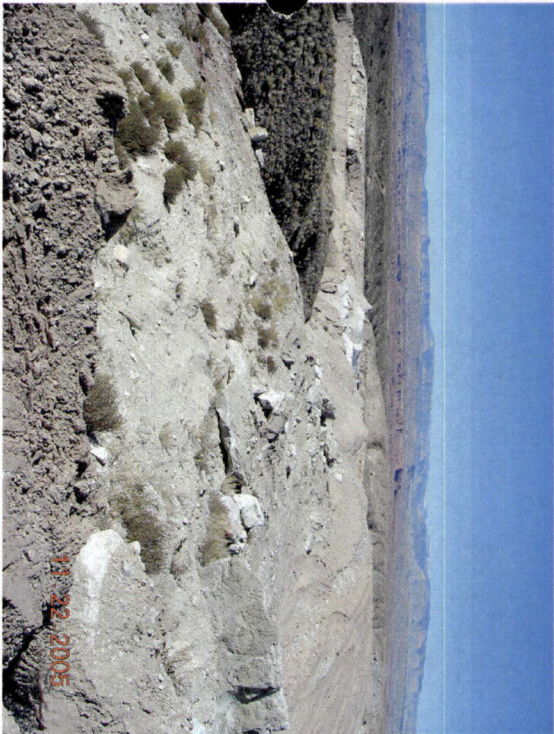
Photo 4. Gravel that the operator is going to try to spread over some of the reclaimed surface.

The soils in the area being reclaimed are fine textured and have very little rock, unlike the areas reclaimed in 2004. This concerns me because rocks tend to increase water infiltration and decrease runoff. There was an area with very gravelly soil on the southwest side of the area being reclaimed, and I suggested to Mr. Henry that, as far as possible, this could be spread over the top of the area being reclaimed.

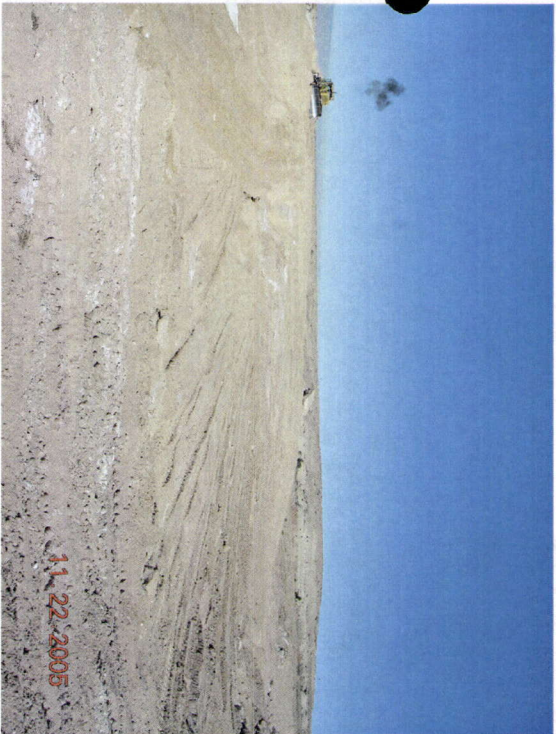
Photo 5. A portion of the reclaimed area. This still needs to be ripped and seeded.

Most of the area being graded still needed to be ripped. This needs to be done parallel to the contour. I am confident the operator well understands the concept of leaving the site rough.

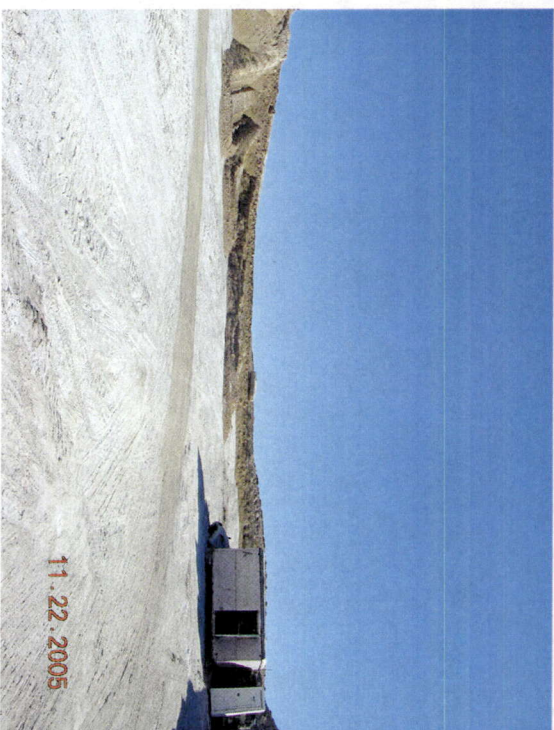
Photo 6 shows the boundary between the area being reclaimed and the active mine. The area being reclaimed is sloped so runoff from this area would go into the active mine which the operator does not want. The operator intends to build a berm across this boundary to divert runoff into a natural drainage channel.

Photo 6. This shows the boundary between the area being reclaimed and the active mine. Runoff from the reclaimed area would flow on to the active mine area, but the operator intends to build a berm to divert this water to a natural drainage.

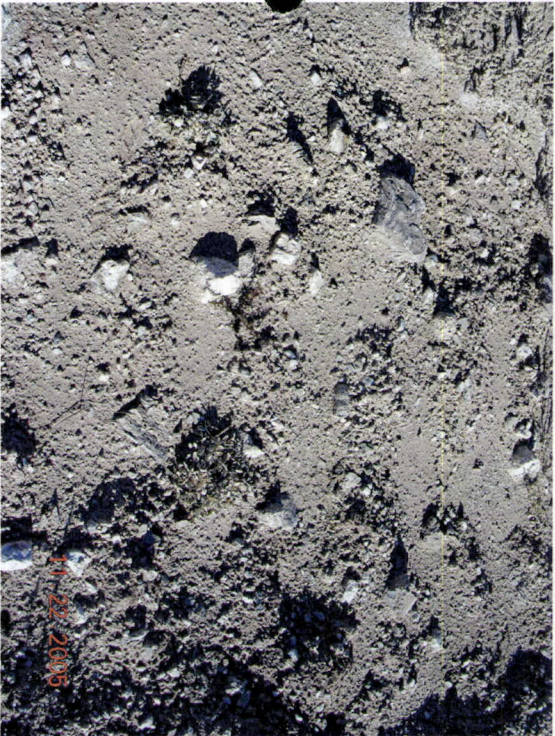
Photo 7. Vegetation in the area reclaimed in 2004.

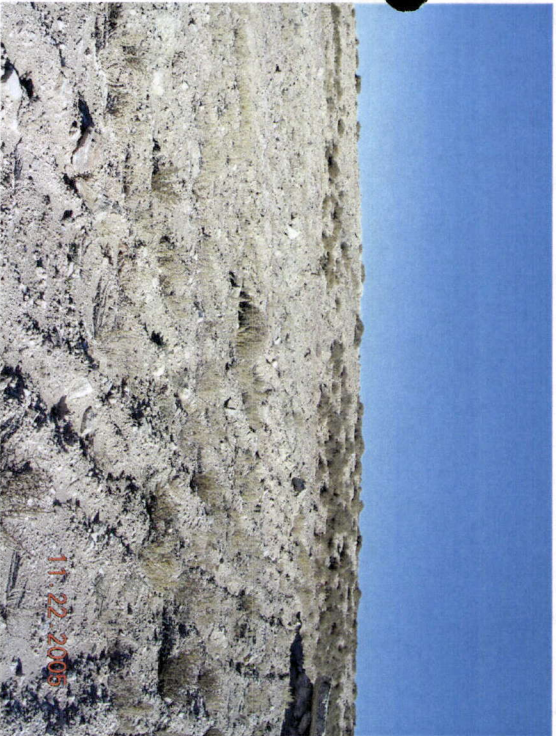
Vegetation in the area that was graded and seeded in 2004 is progressing well. This area is shown in Photos 8 and 9. There is a nice mixture of grasses and shrubs. I cannot yet identify the grasses, but they did not look like Indian ricegrass. Most of the shrubs appear to be Castle Valley clover and fourwing saltbush, but when the shrubs are this small, I have trouble distinguishing between shadscale and Castle Valley clover.

Photo 8. An overview of some of the area reclaimed in 2004.

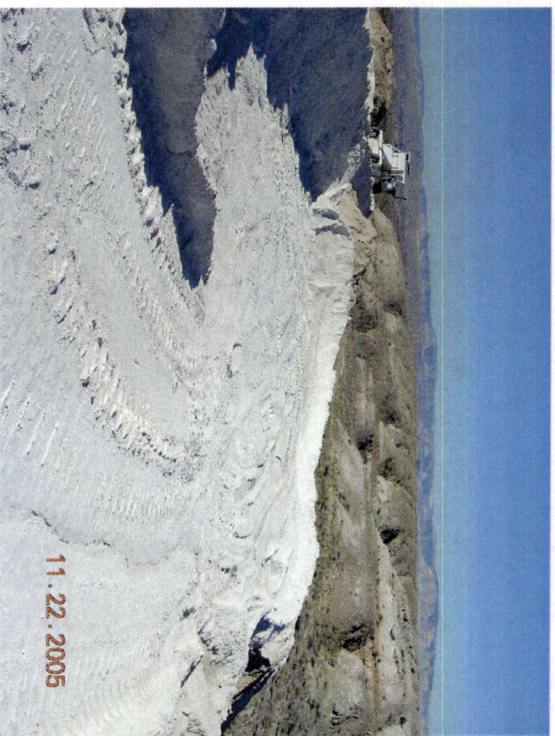
Photo 9. The operator intends to construct a small pond in this area to hold runoff from the upper part of the active mine.

I suggest that the operator install a notched silt fence to serve as the outlet for the upper catch basin. This would need to be keyed in to the embankment so it doesn't wash out.

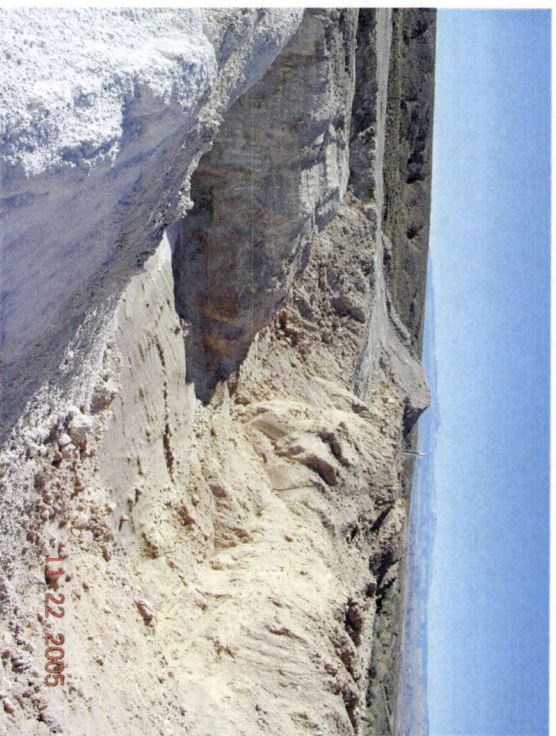
There is already a depression at the lower end of the quarry that serves as a catch basin (Photo 10), and this appears to be large enough that it has not caused problems.

Photo 10. A depression in the lower portion of the active mine.
